Case Study Of Abrasion Of The Musi River Bad Due To Water Waves In Coastal Prajin Village, Banyuasin I District, South Sumatera Province

Surnata¹, Irwan², Bambang Setiawan³, Purboyo⁴, Febriansyah⁵, Sri Kelana⁶

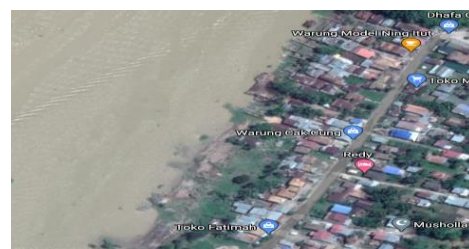
This can be seen from the loss of several meters of land up to 20 meters from the river bank and until the houses of residents are flooded by the tide so that they can no longer be used properly. The following is a description of the conditions in the Village of Craftsmen on the outskirts of the Musi River.

Picture 5 Residential Houses Affected by Abrasion

This picture shows the abrasion that started several years ago which resulted in several houses being flooded by the Musi River, under normal conditions. According to one resident, at high tide the sea water can reach a height of +50 cm accompanied by waves that directly hit the walls of the house. The picture shows the area of people's houses that have been submerged by the water of the Musi River, so they can no longer be used. In the coastal area, there are 4 villages that are threatened with abrasion, namely Prajin Pesisir Village on the Musi River coast. is a beach that

With the wave pressure as big as what was mentioned above, it will cause the cliff walls to erode, so the author gives input that it should be given a cliff protector using a gabion or shit file
